Connector Protection

Problem Scope

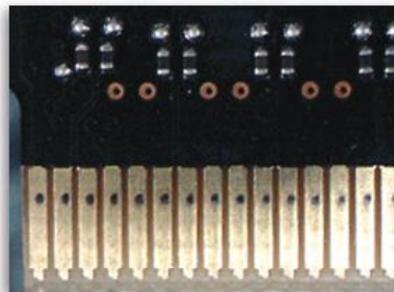
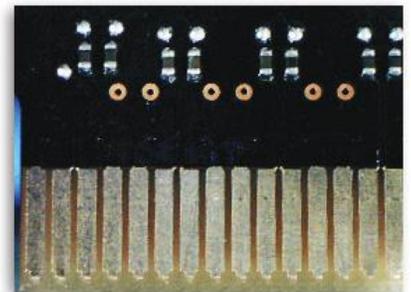
Video Card

Photographs of contacts following prolonged shock and vibration testing

Untreated

Treated

The systems were then disassembled and the connections were cleaned and inspected. The example photograph of the video card contacts shows that the non-lubricated connectors have visible pitting at the highest compression point of the contact as well as longer, shallower wear lines over the length of the contact. In both tests, the lubricated connectors show minimal wear.

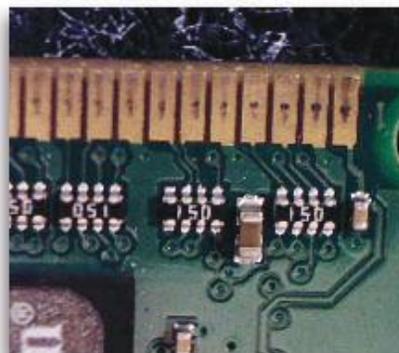
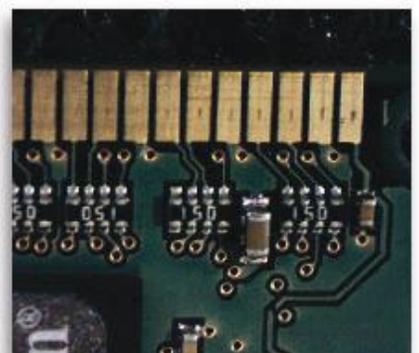
Memory Module

Untreated

Treated
